Heavy Preloading and Consolidation of Soft Soil Masses with the Use of Reinforced Embankment and Vertical Drains

J. Sobolewski, HUESKER, Germany; V. Radovanović, Kolubara, Serbia

A large part of field "B" in the open cast coal mine "Kolubara", in the Republic of Serbia, was covered by soil masses slid from the disposal area in March-April 2006. This landslide with a length of approx. 2 km and the width of more than 400 m stopped the coal excavation. The coal stratum was covered by 30 - 40 m thick very soft soil deposits. A heavy pre-loading consisting of a 9.5 m high embankment and an accelerated consolidation by the use of vertical drains for an improvement of soft deposits was selected to solve this problem. A high tensile strength geosynthetic reinforcement placed at the base of the embankment allowed for a short construction time. After consolidation 25 samples were taken at different locations and depths and a reasonable improvement of the shear strength could be confirmed. Due to this the embankment could be removed and the 1:6 sloped excavation down to the coal roof was performed. The coal excavation was reopened in January 2009.

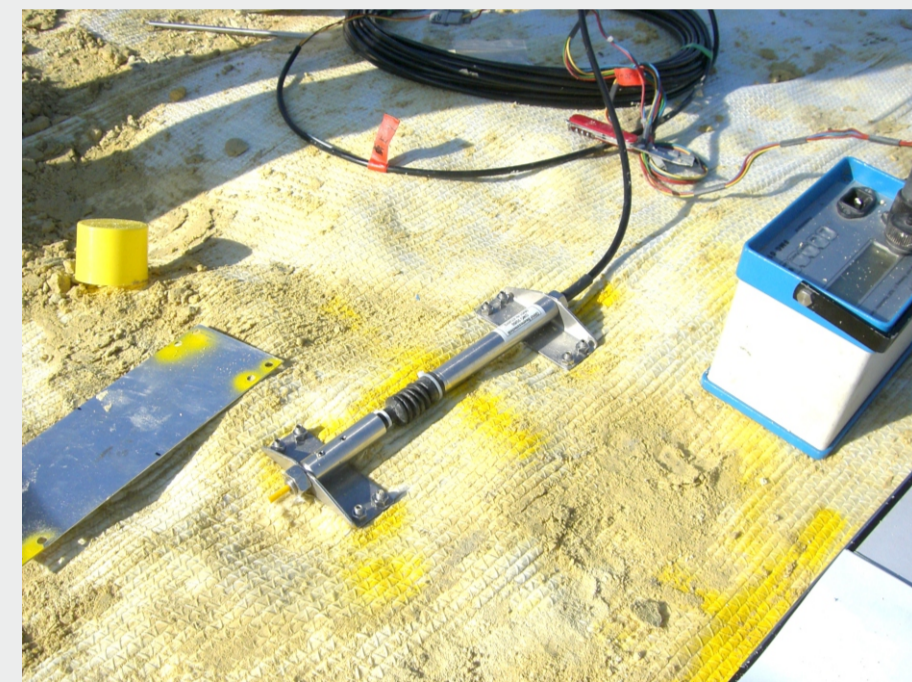
Installation of an extensometer on Stabilenka® 1600/100 PES

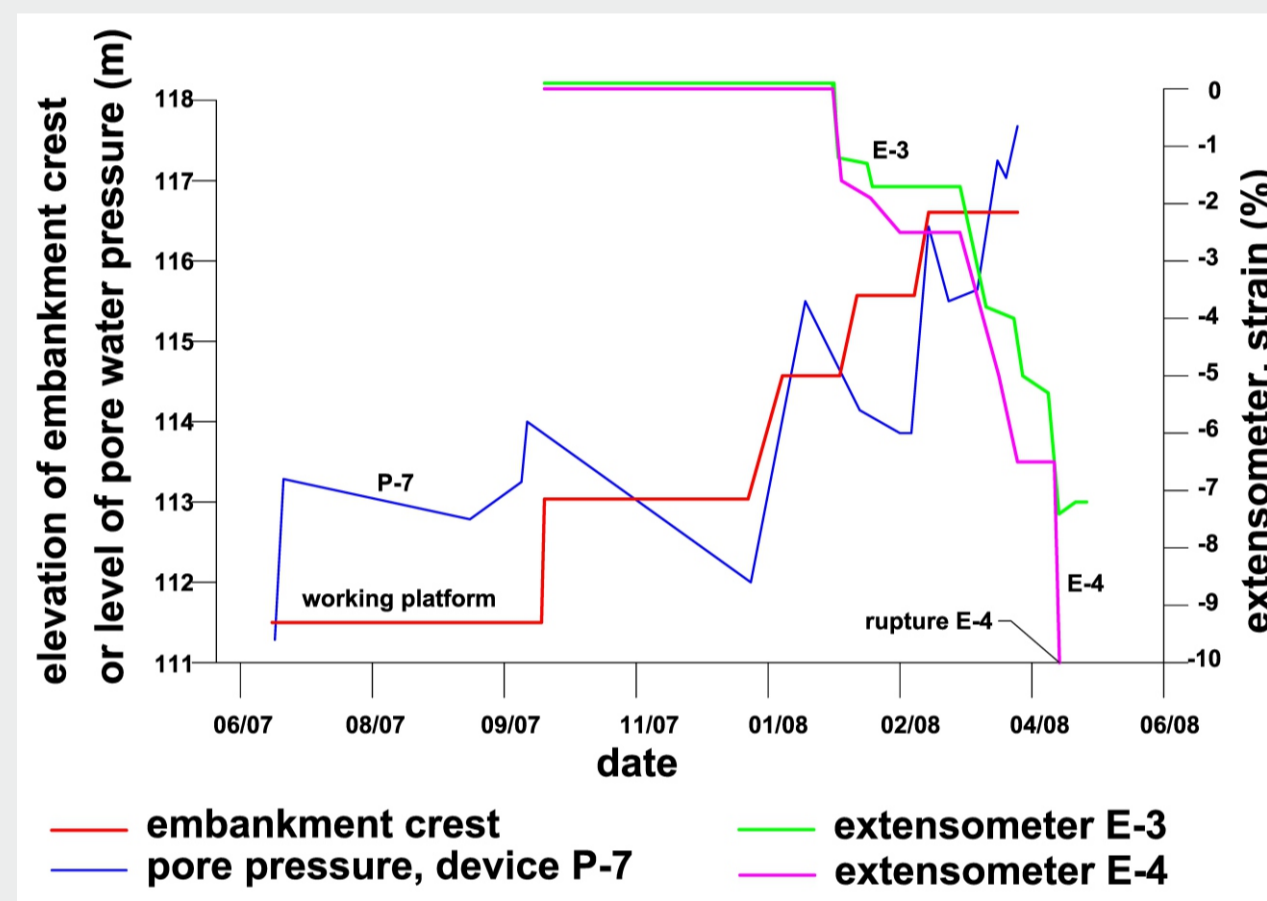
Results of monitoring during construction works and preloading

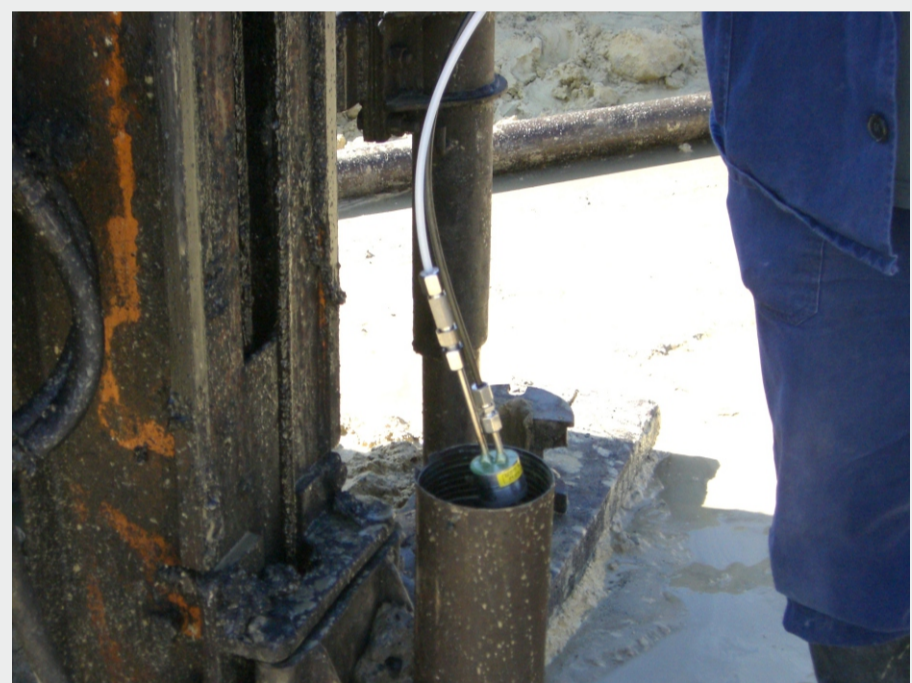
Installation of a pore pressure device

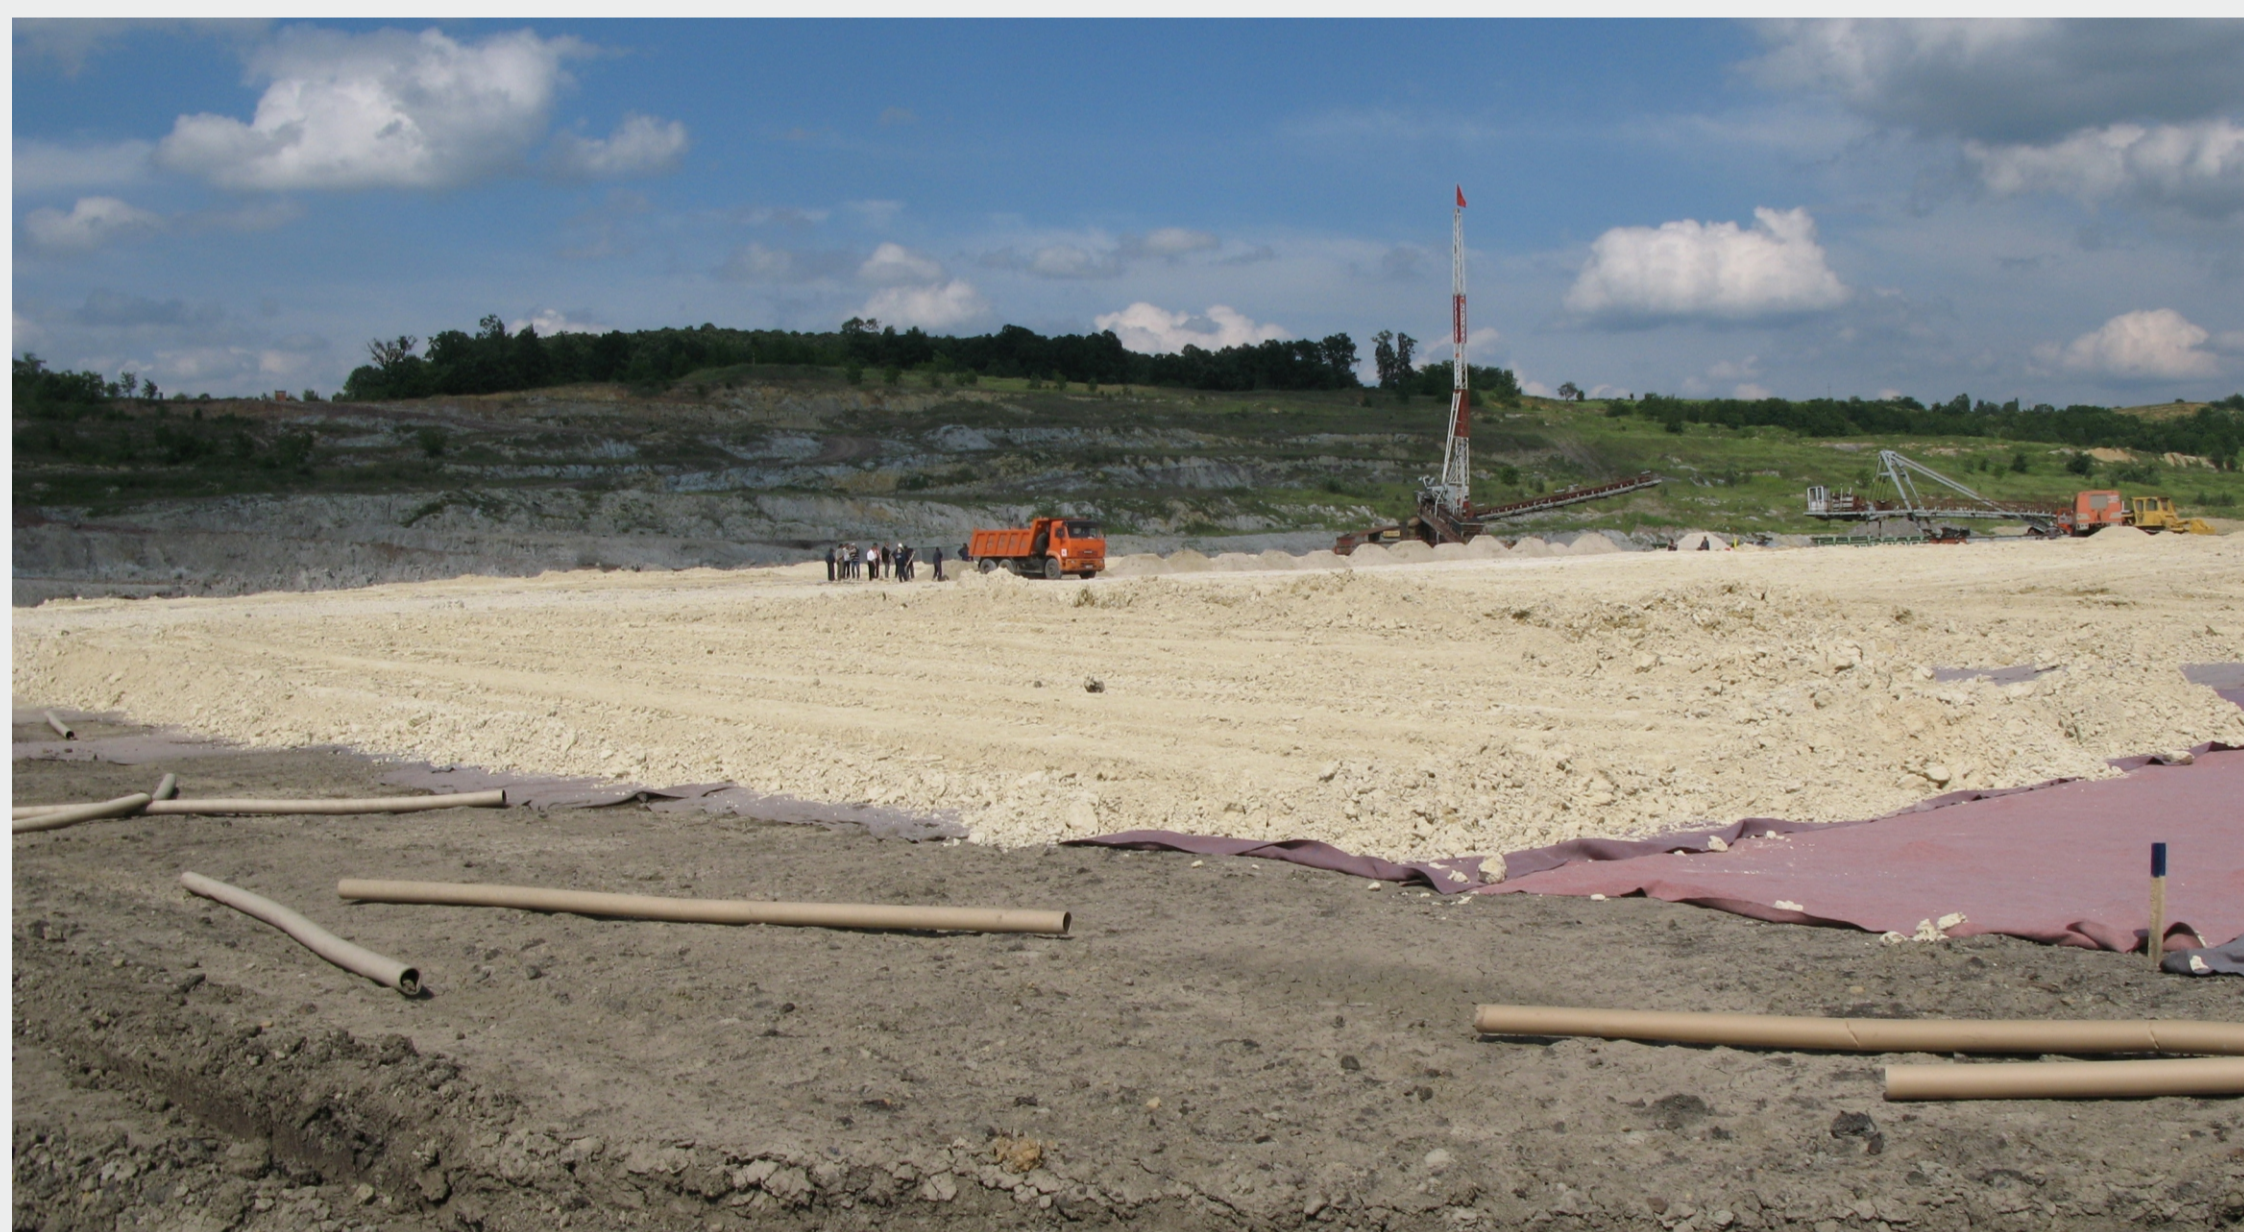
Base preparation: levelling of surface, installation of non-woven, placement of 20 cm sand layer

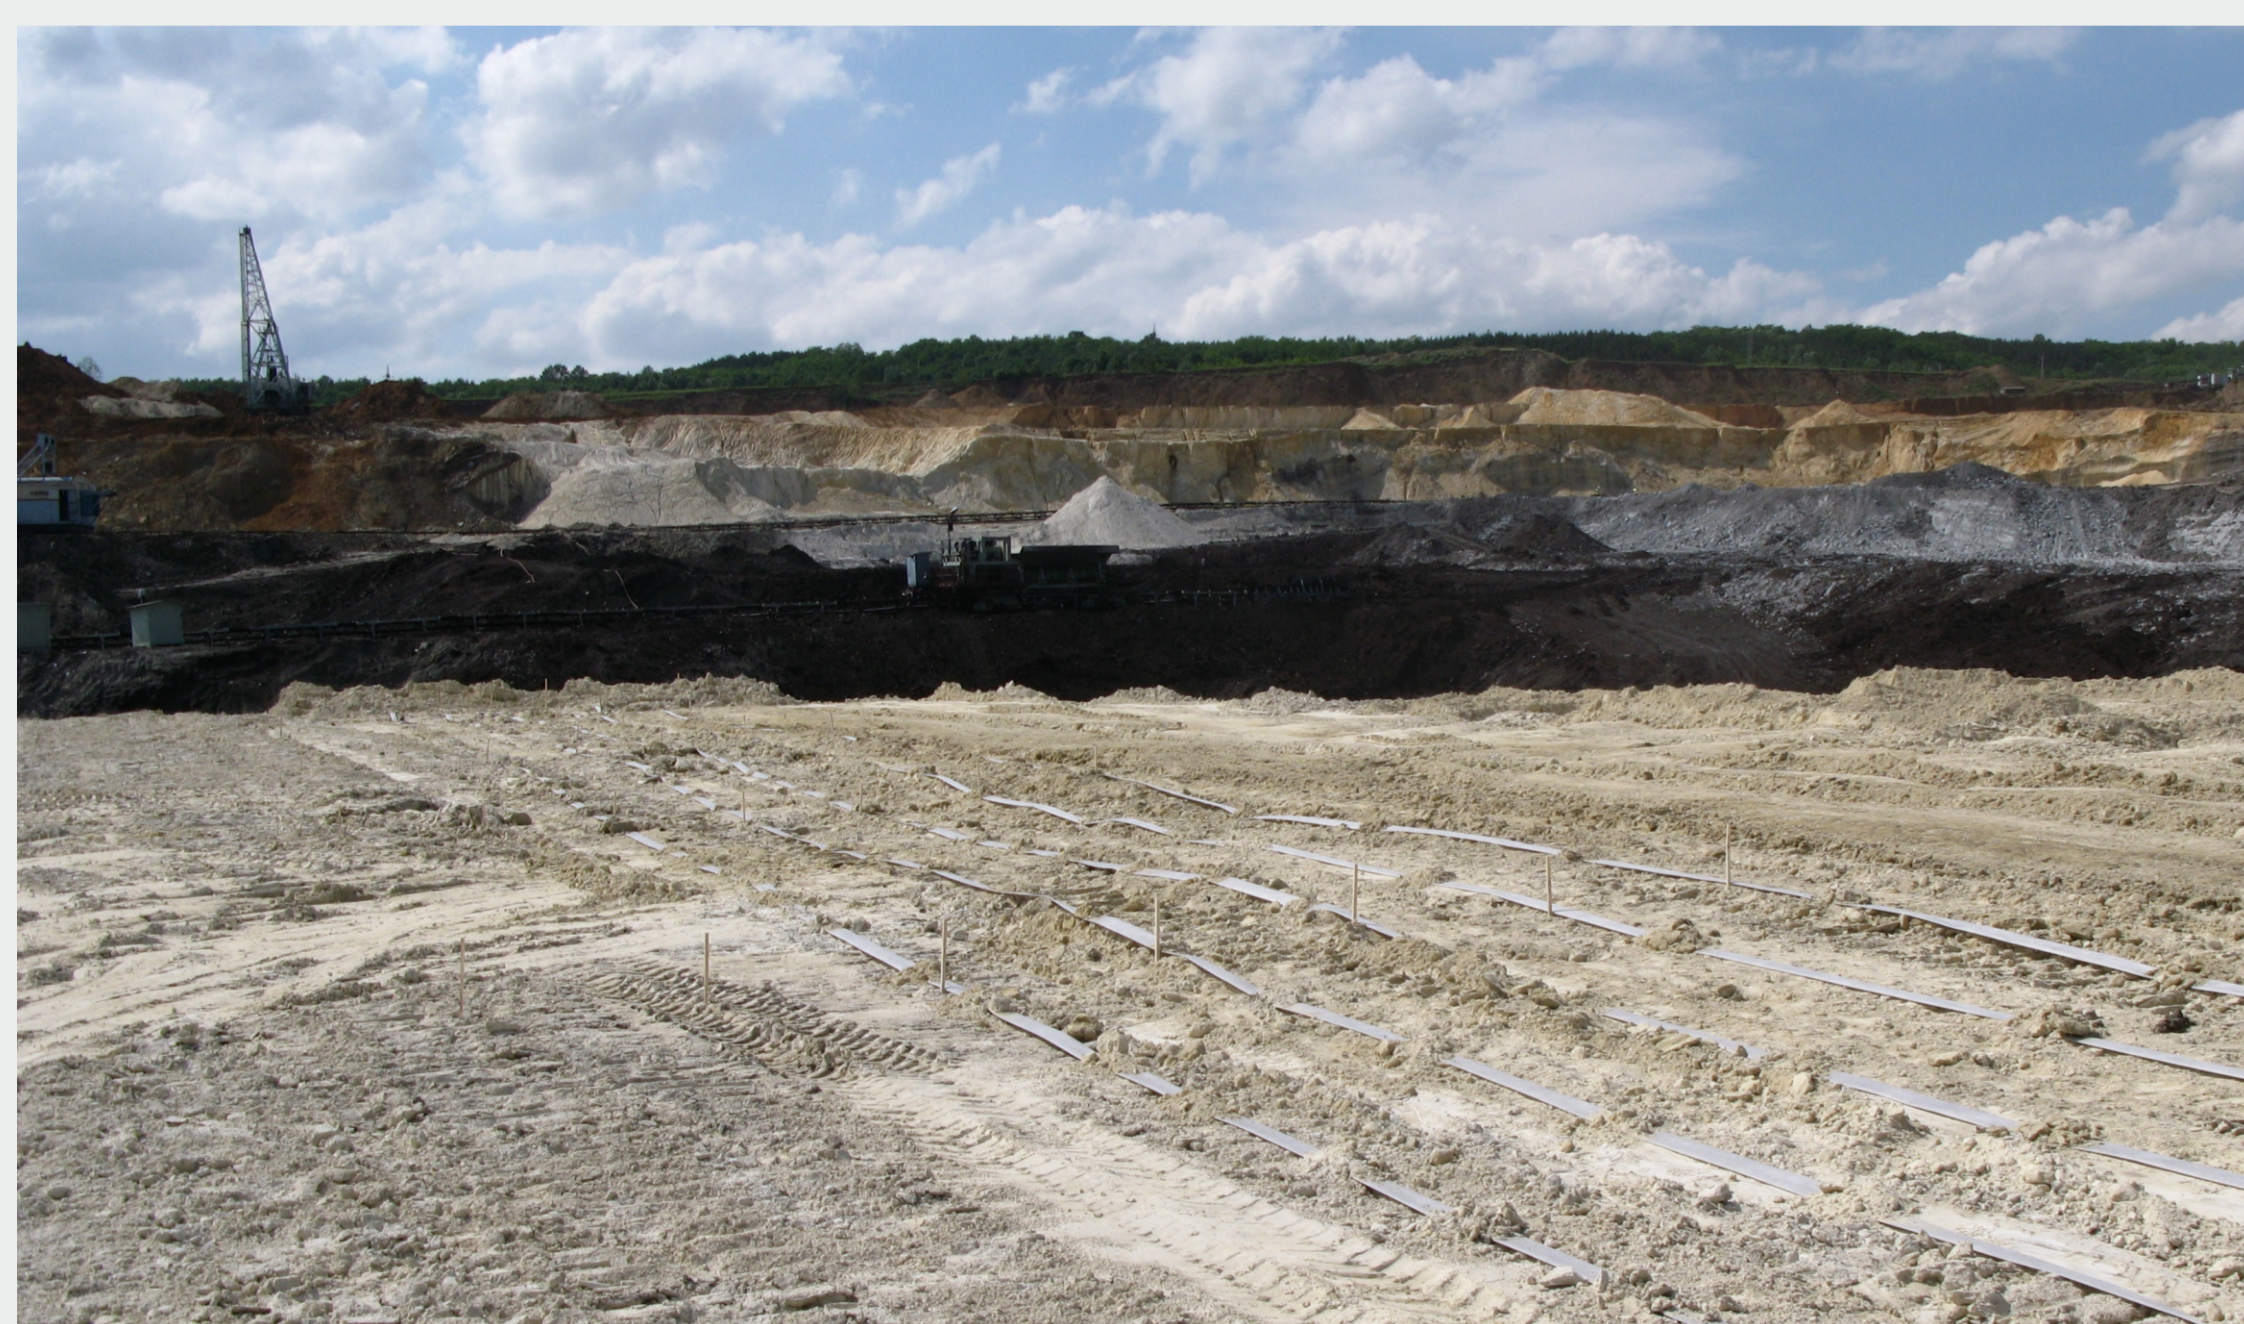
Horizontal installed geosynthetic drains in the spacing of 1.0 m on the base of working platform

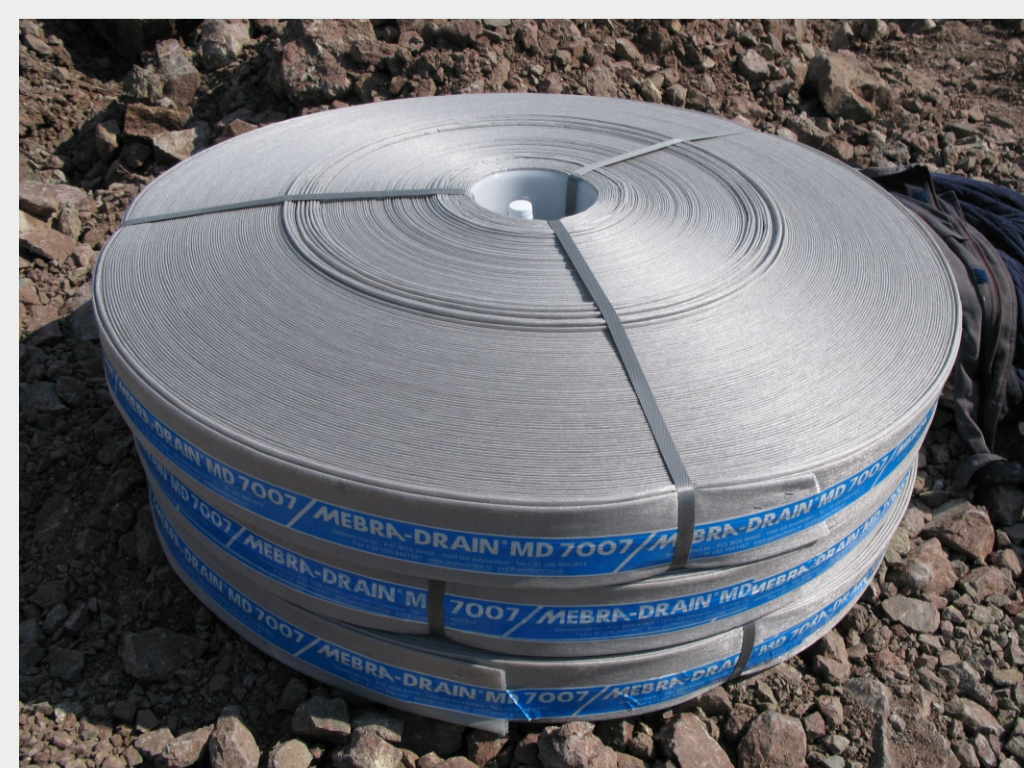
Installation of vertical drains in triangle spacing, 1.25 m on the top of working platform

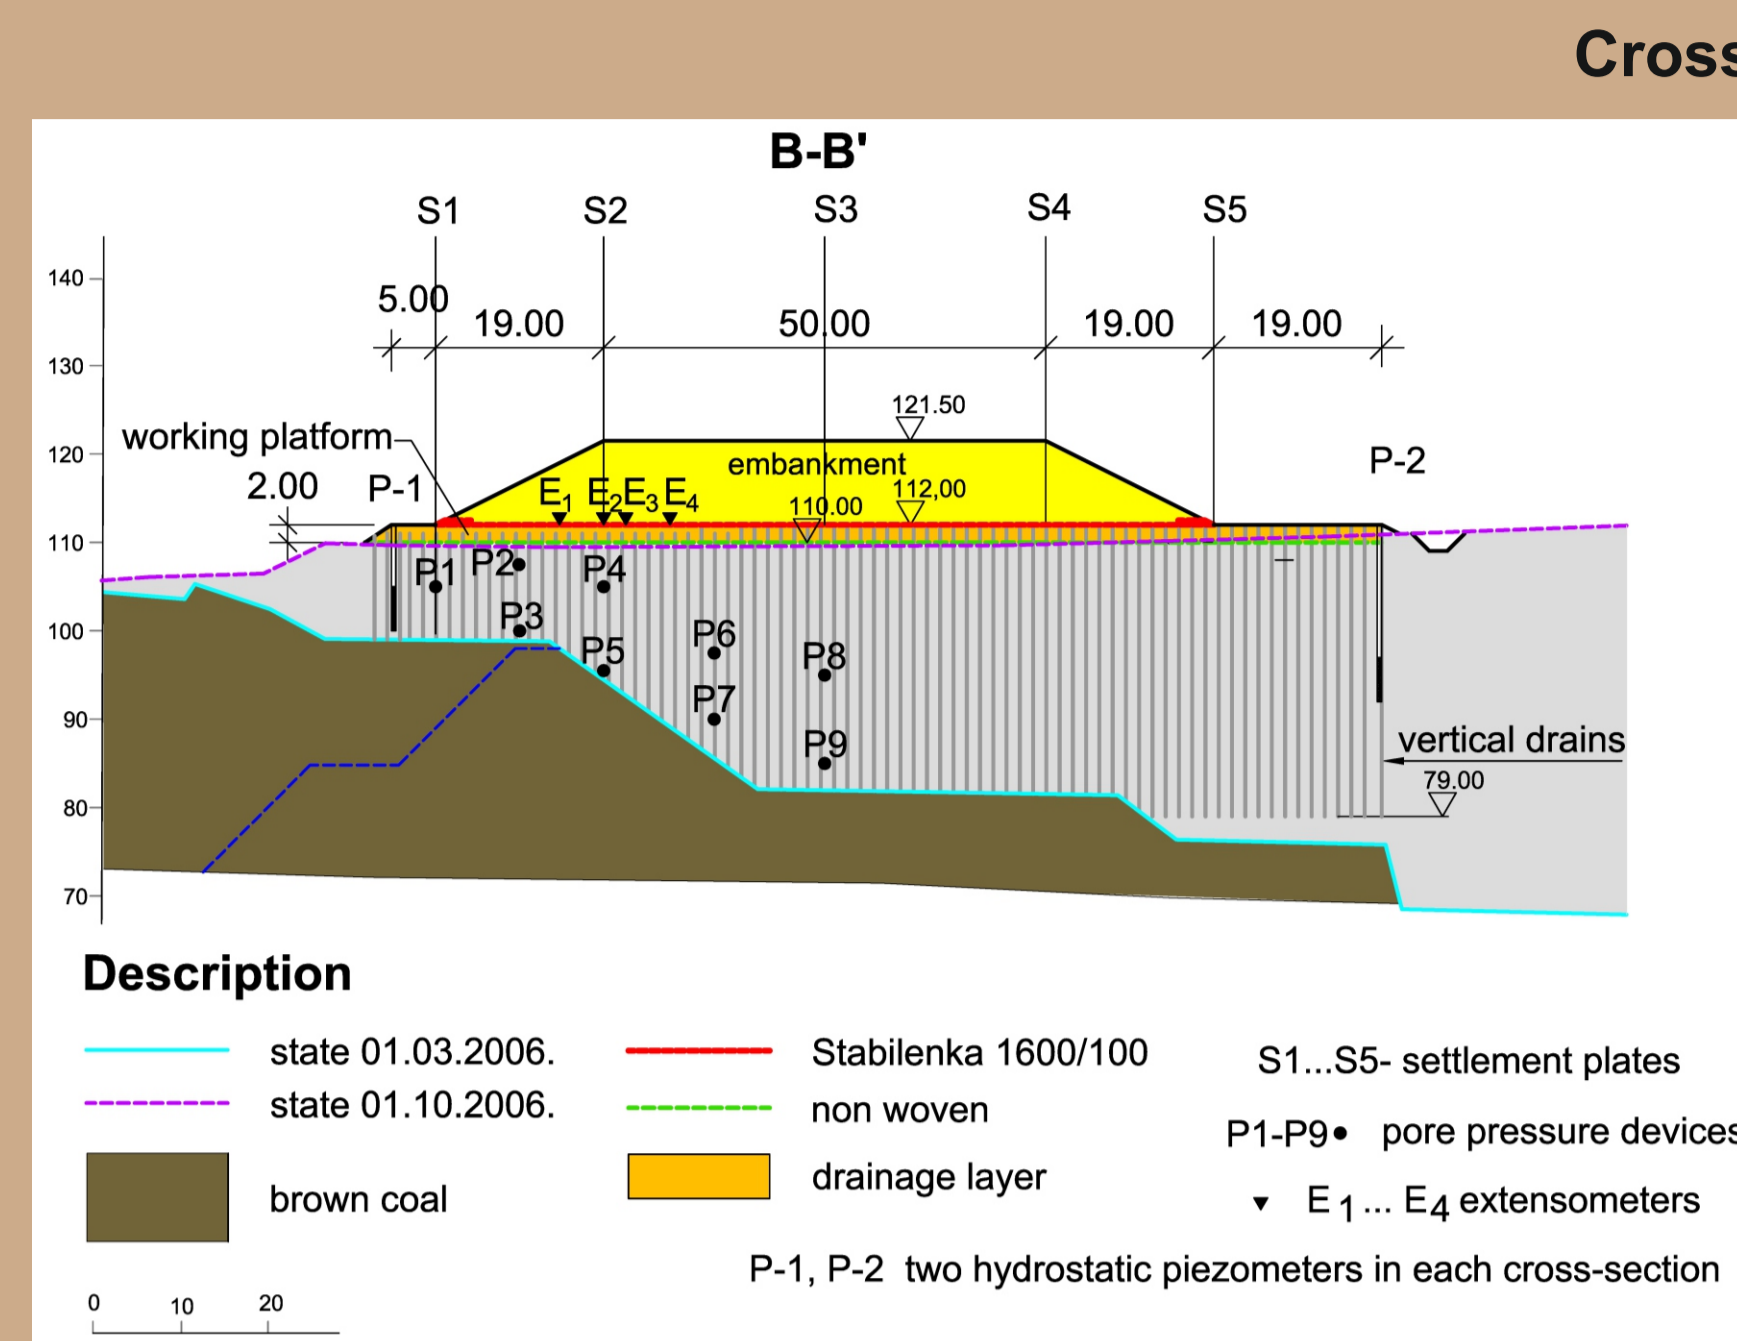
Embankment for preloading, monitoring plan

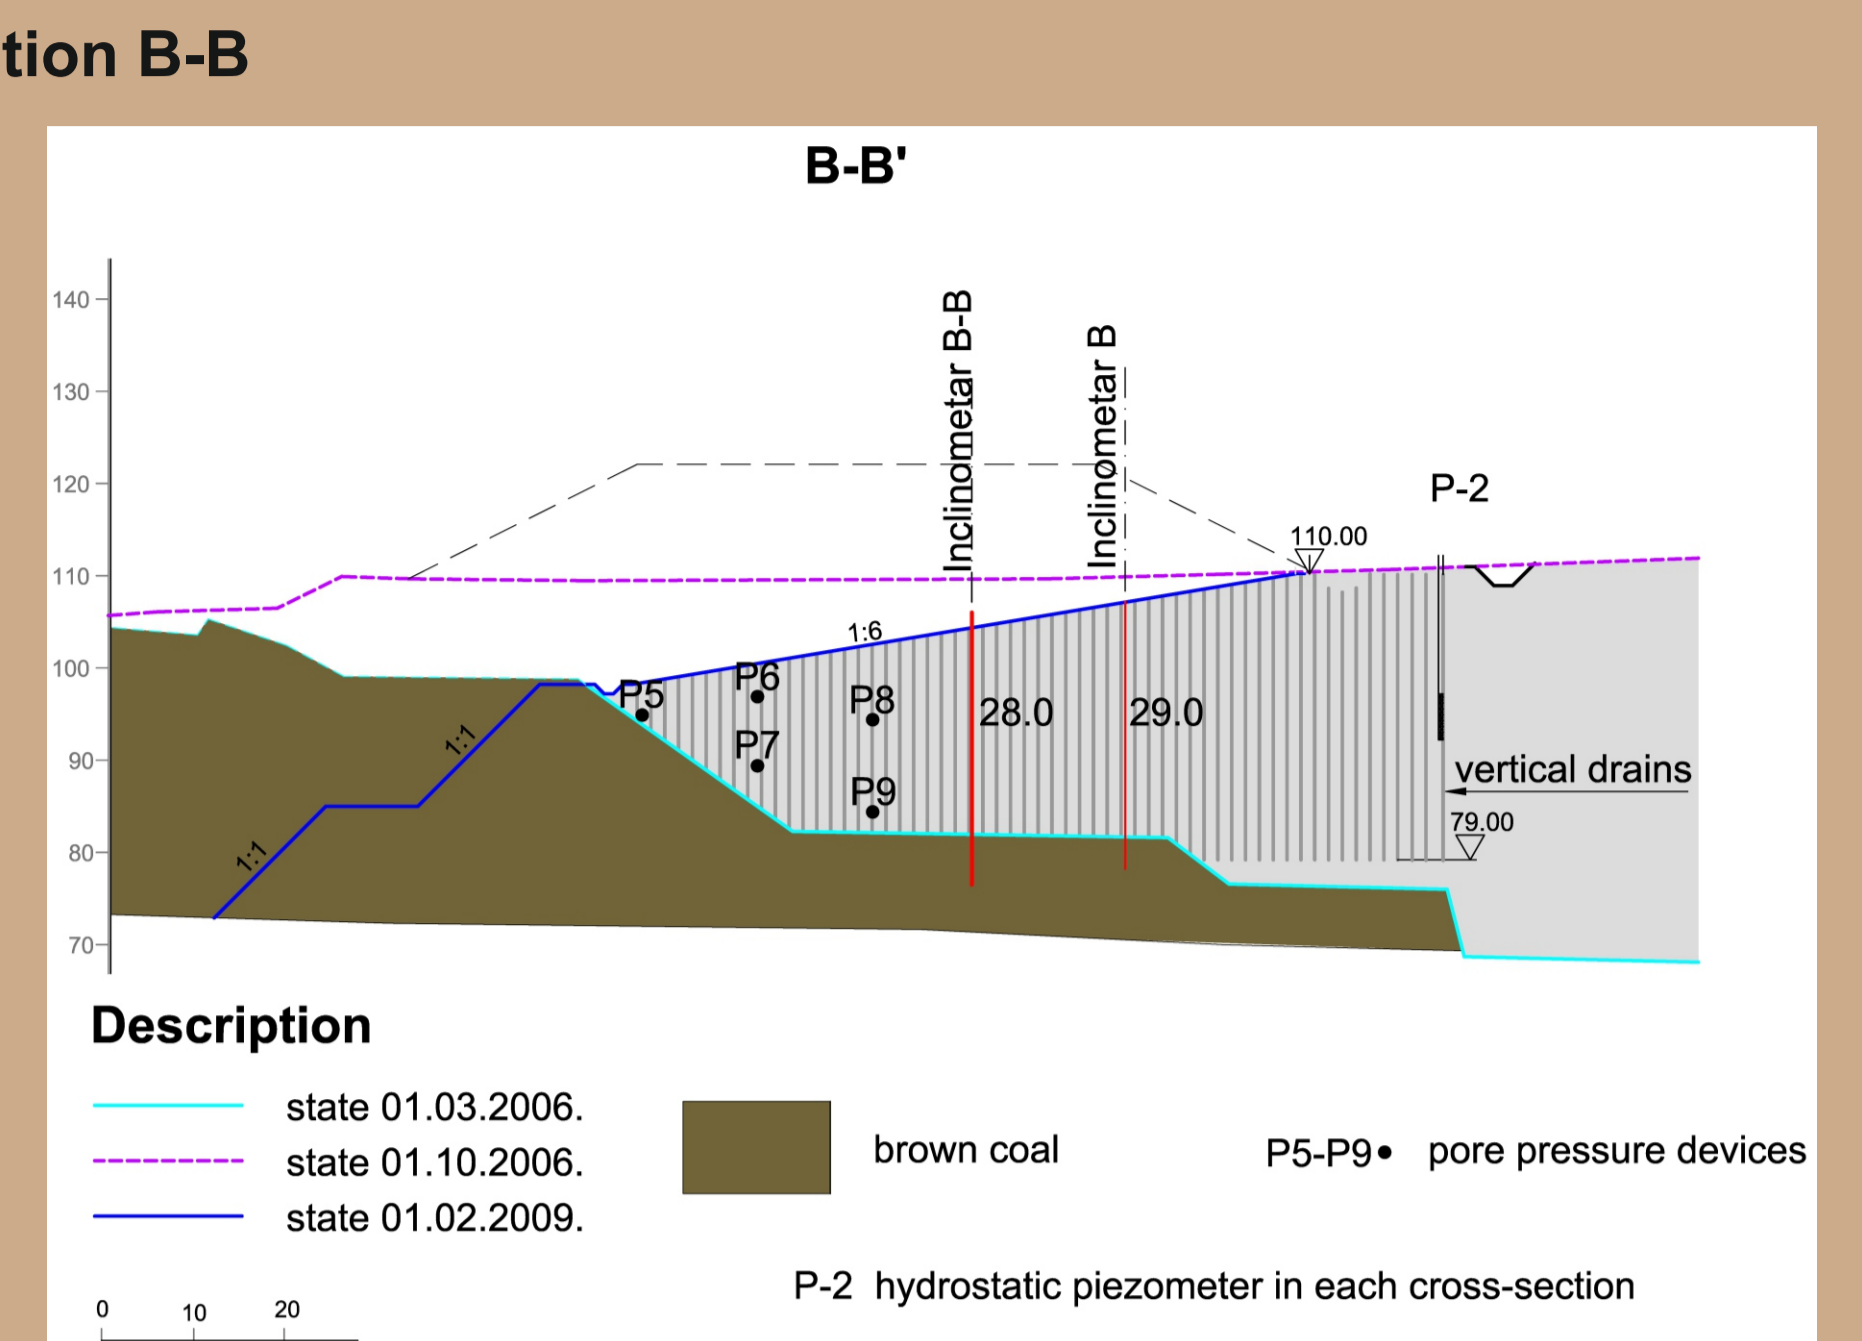
Excavation to the coal stratum

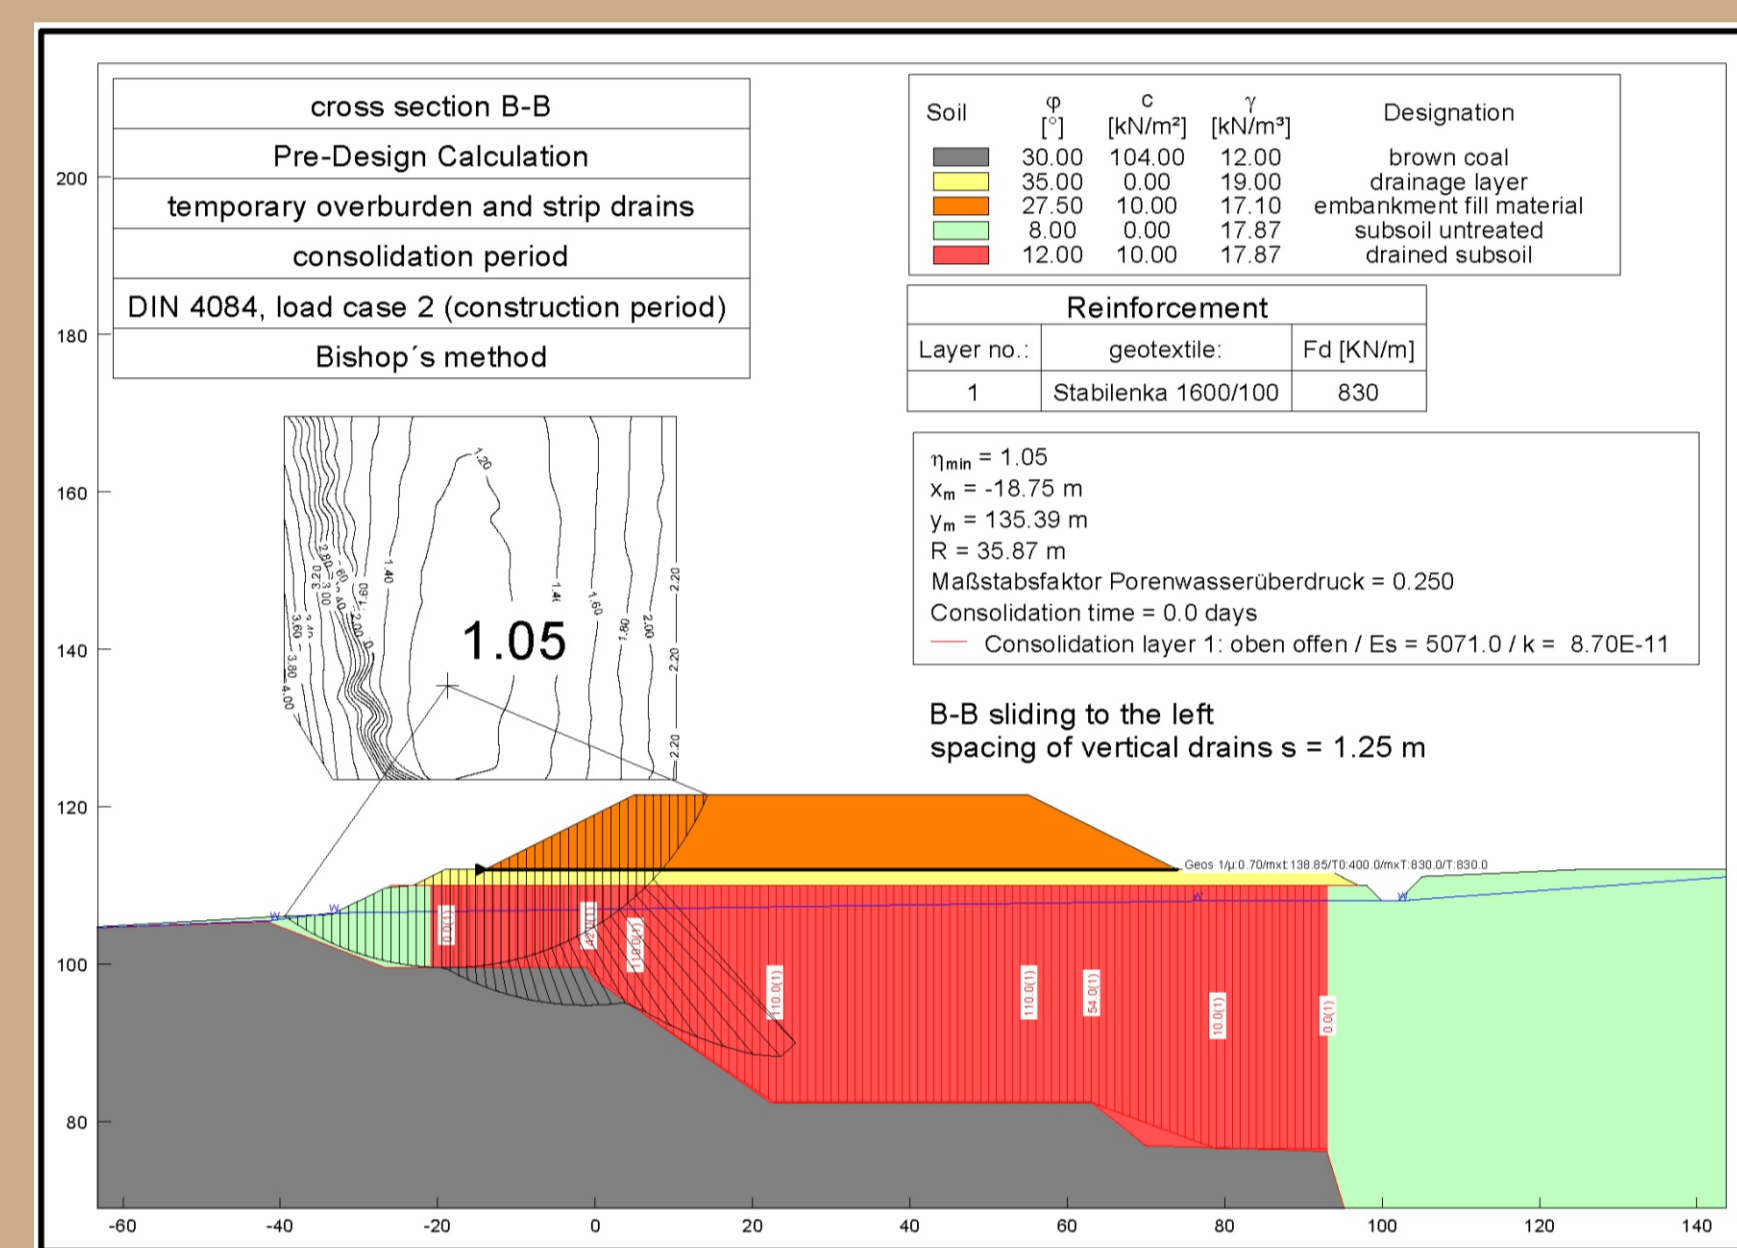
Stability analysis of embankment, Bishop's method

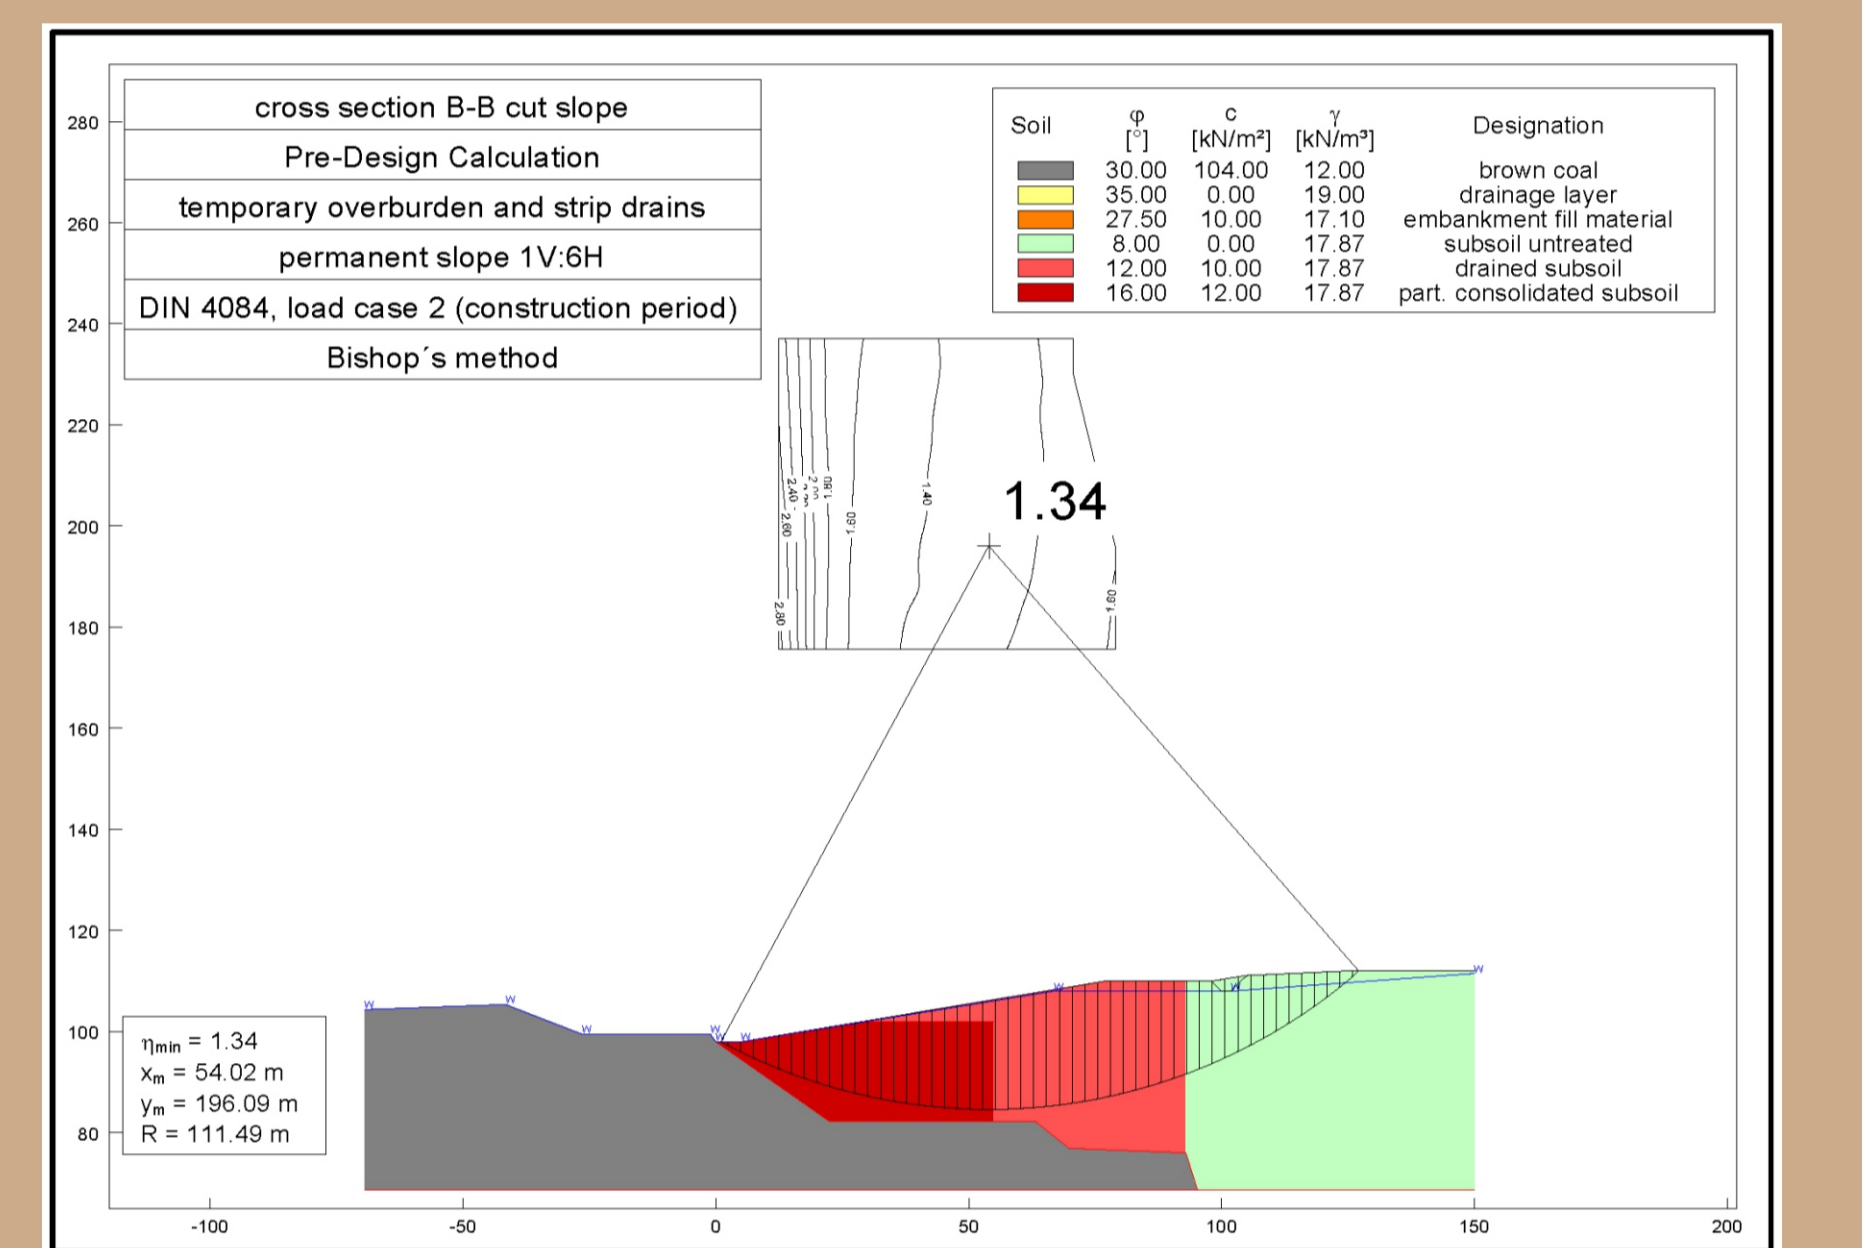
Stability analysis of excavated slope after pre-loading, Bishop's method

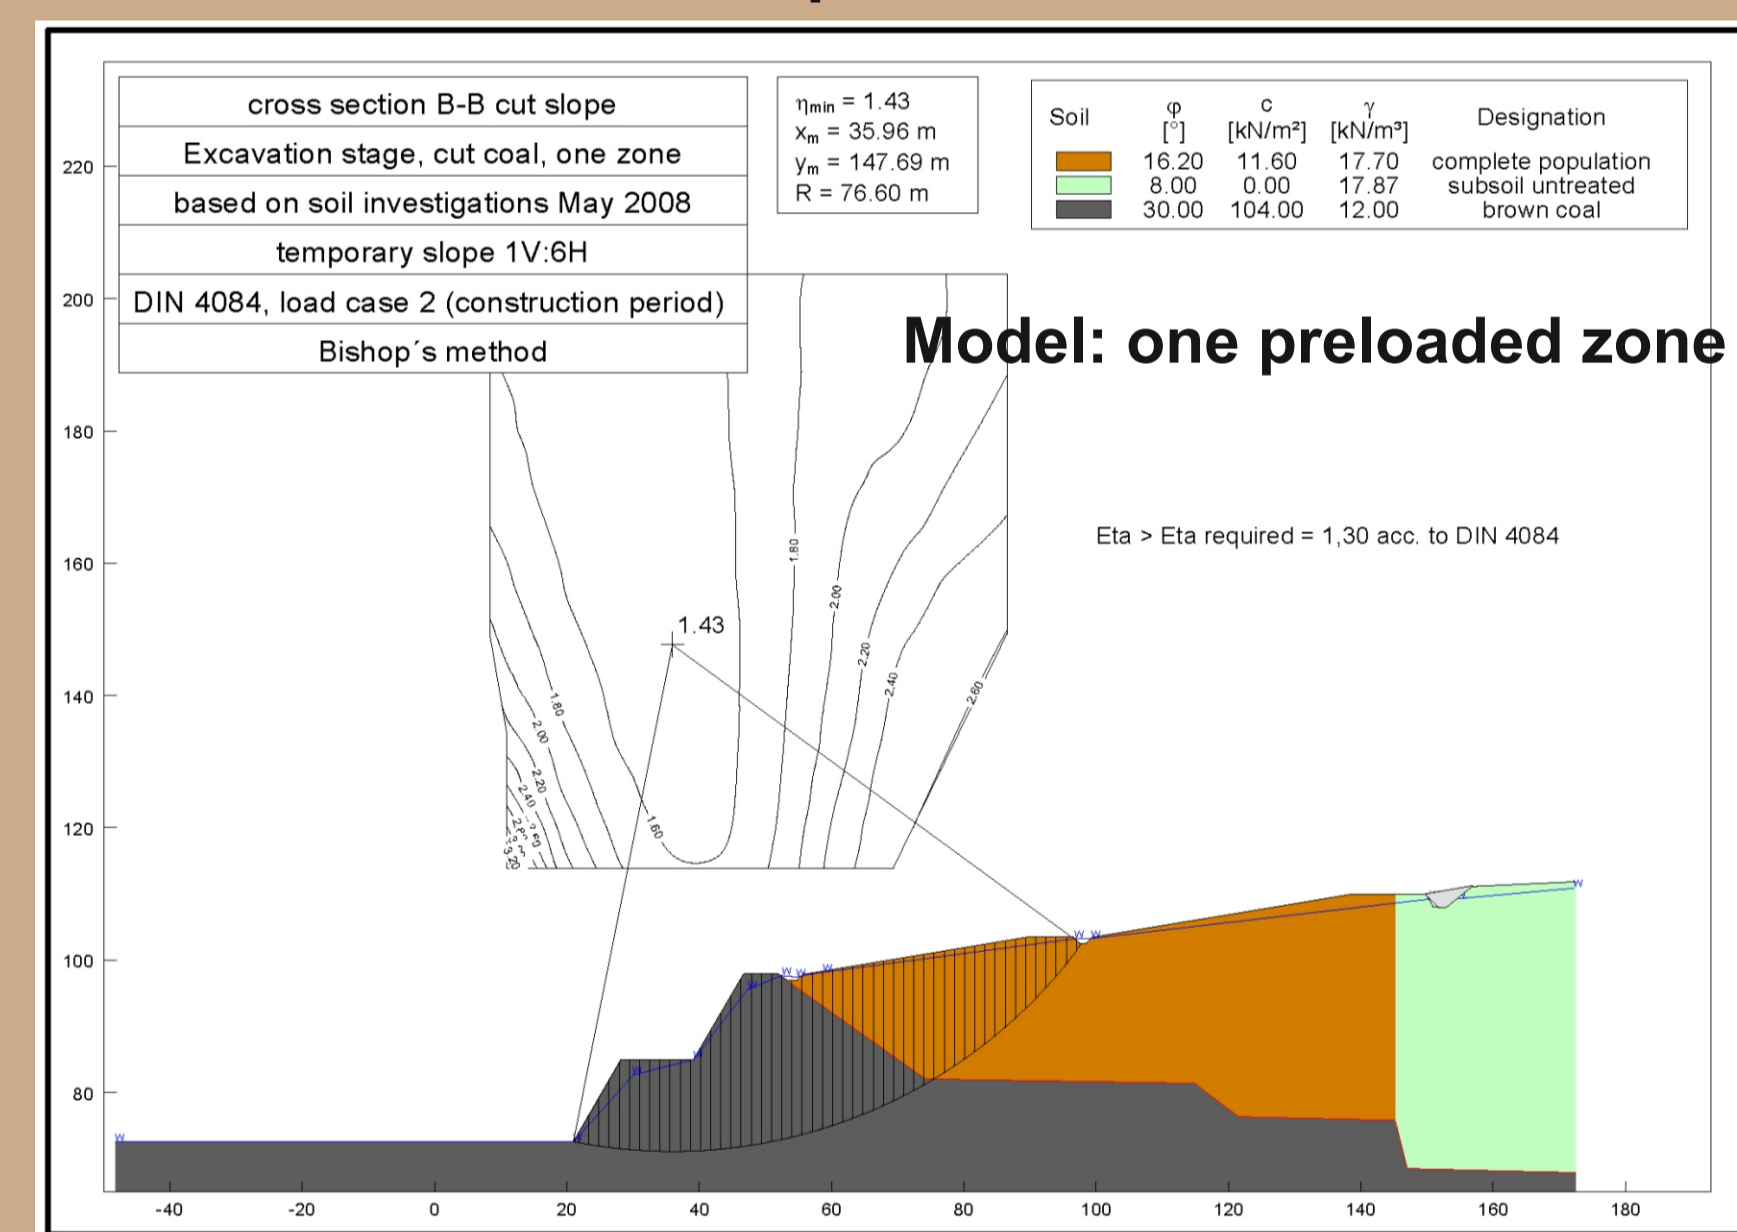
Stability analysis of excavated slope: estimated soil parameters after preloading, Bishop's method

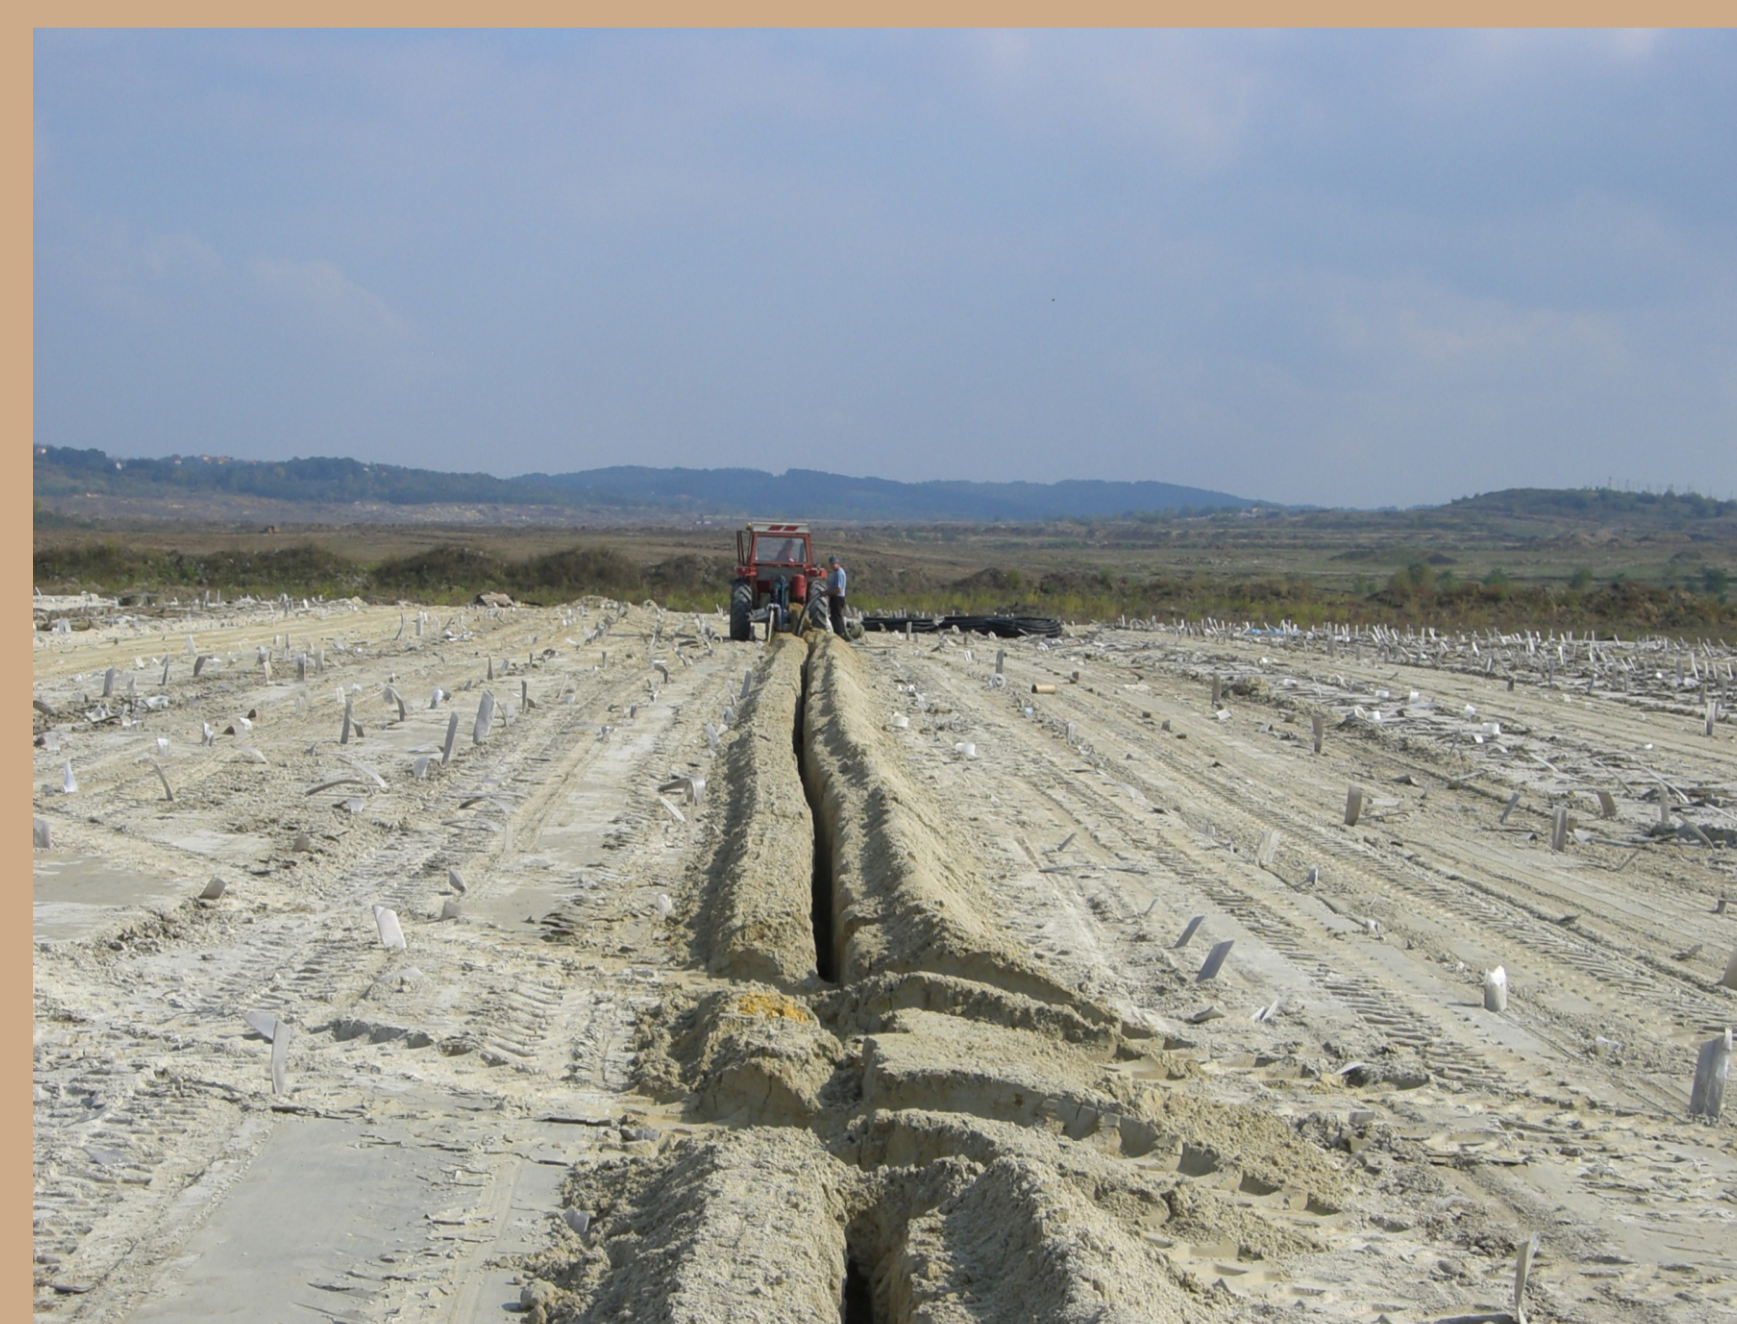
Installation of drainage pipes in the working platform, spacing 10 m
