Heavy Preloading and Consolidation of Soft Soil Masses with the Use of Reinforced Embankment and Vertical Drains

J. Sobolewski, HUESKER, Germany; V. Radovanović, Kolubara, Serbia

A large part of field "B" in the open cast coal mine "Kolubara", in the Republic of Serbia, was covered by soil masses slid from the disposal area in March-April 2006. This landslide with a length of approx. 2 km and the width of more than 400 m stopped the coal excavation. The coal stratum was covered by 30 - 40 m thick very soft soil deposits. A heavy pre-loading consisting of a 9.5 m high embankment and an accelerated consolidation by the use of vertical drains for an improvement of soft deposits was selected to solve this problem. A high tensile strength geosynthetic reinforcement placed at the base of the embankment allowed for a short construction time. After consolidation 25 samples were taken at different locations and depths and a reasonable improvement of the shear strength could be confirmed. Due to this the embankment could be removed and the 1:6 sloped excavation down to the coal roof was performed. The coal excavation was reopened in January 2009.

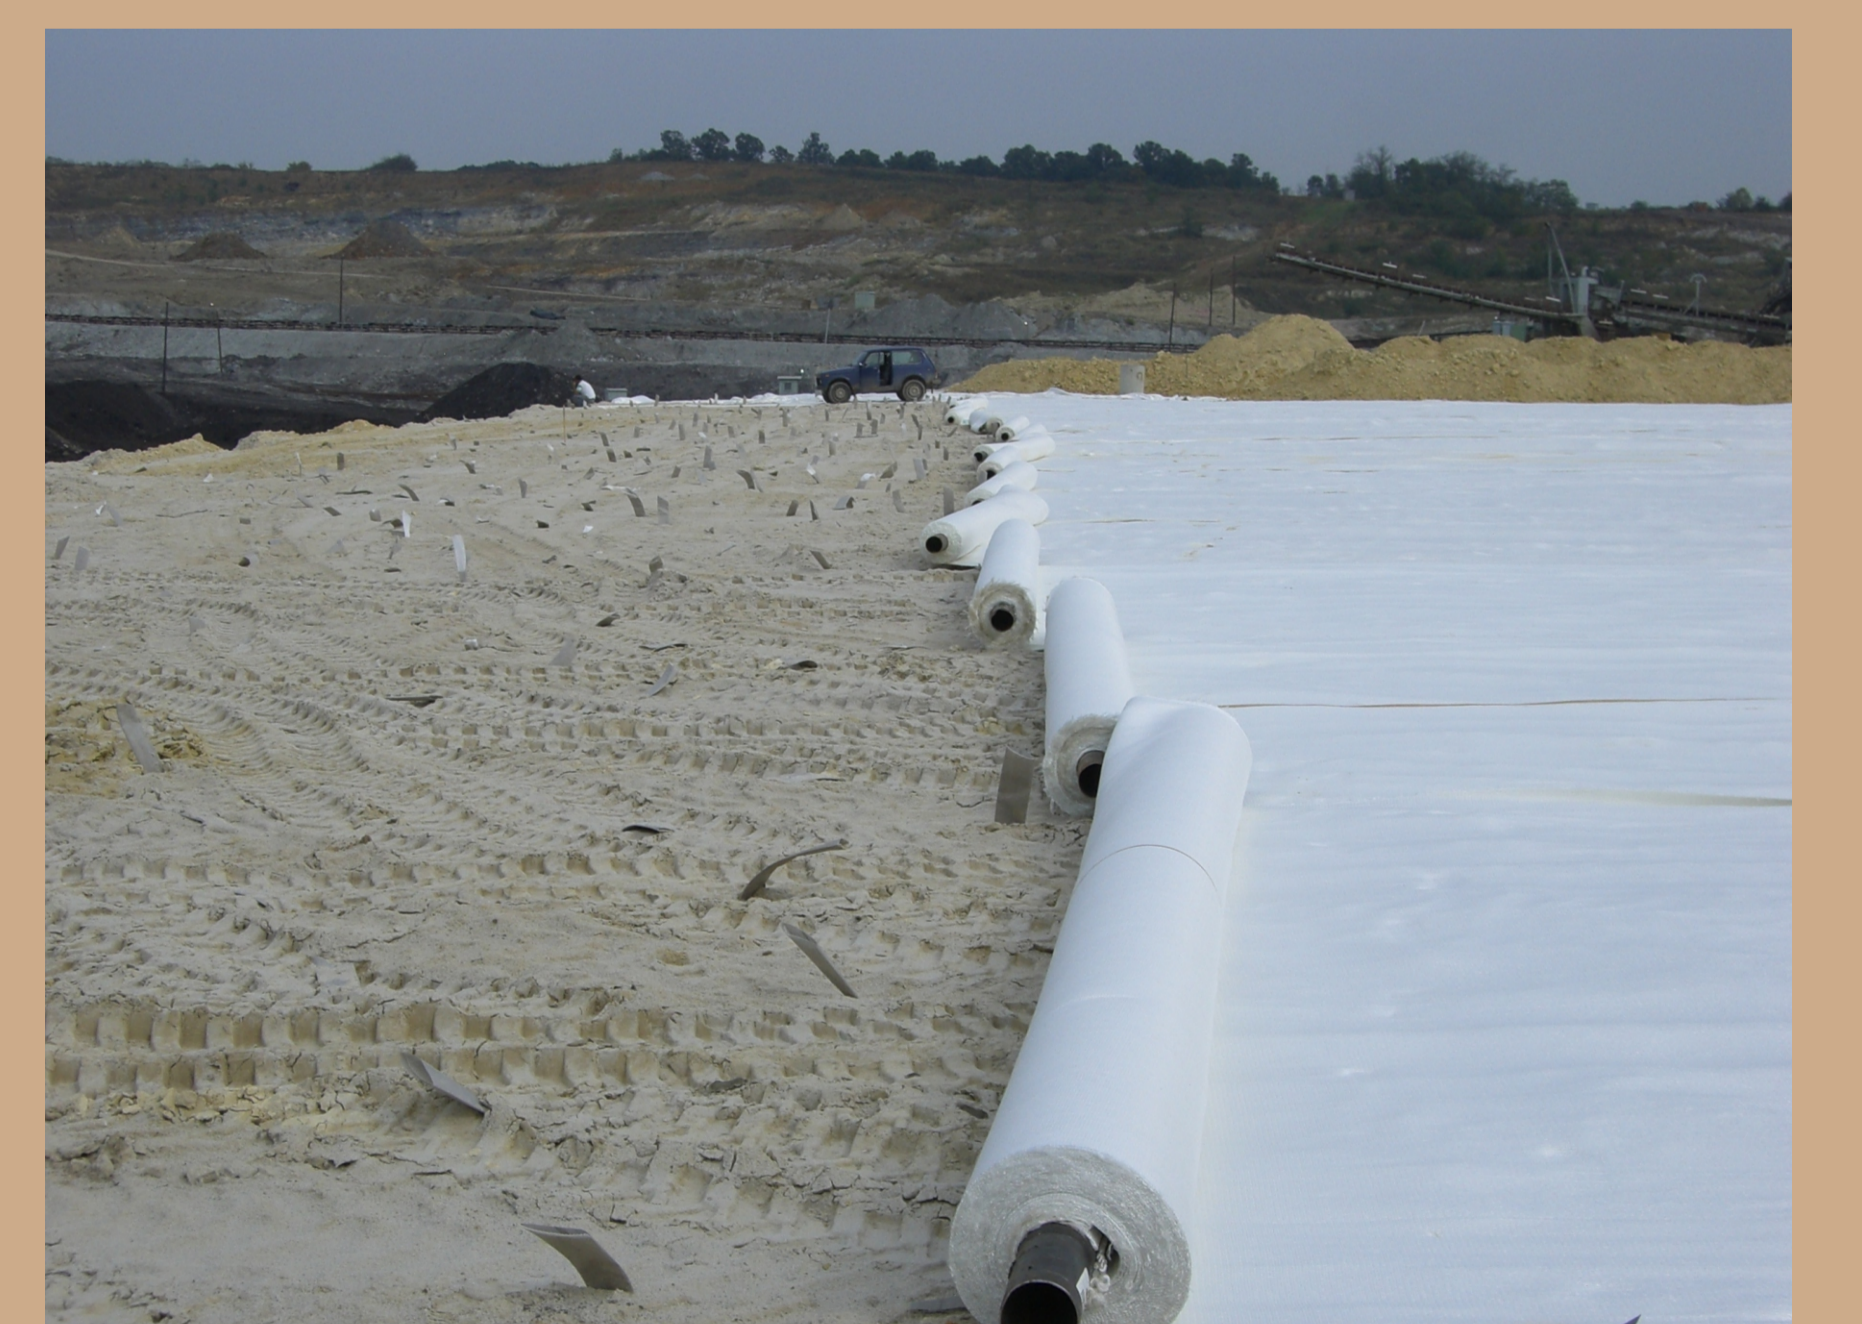
Installation of basal reinforcement, woven fabric made of polyester UTS = 1600 kN/m

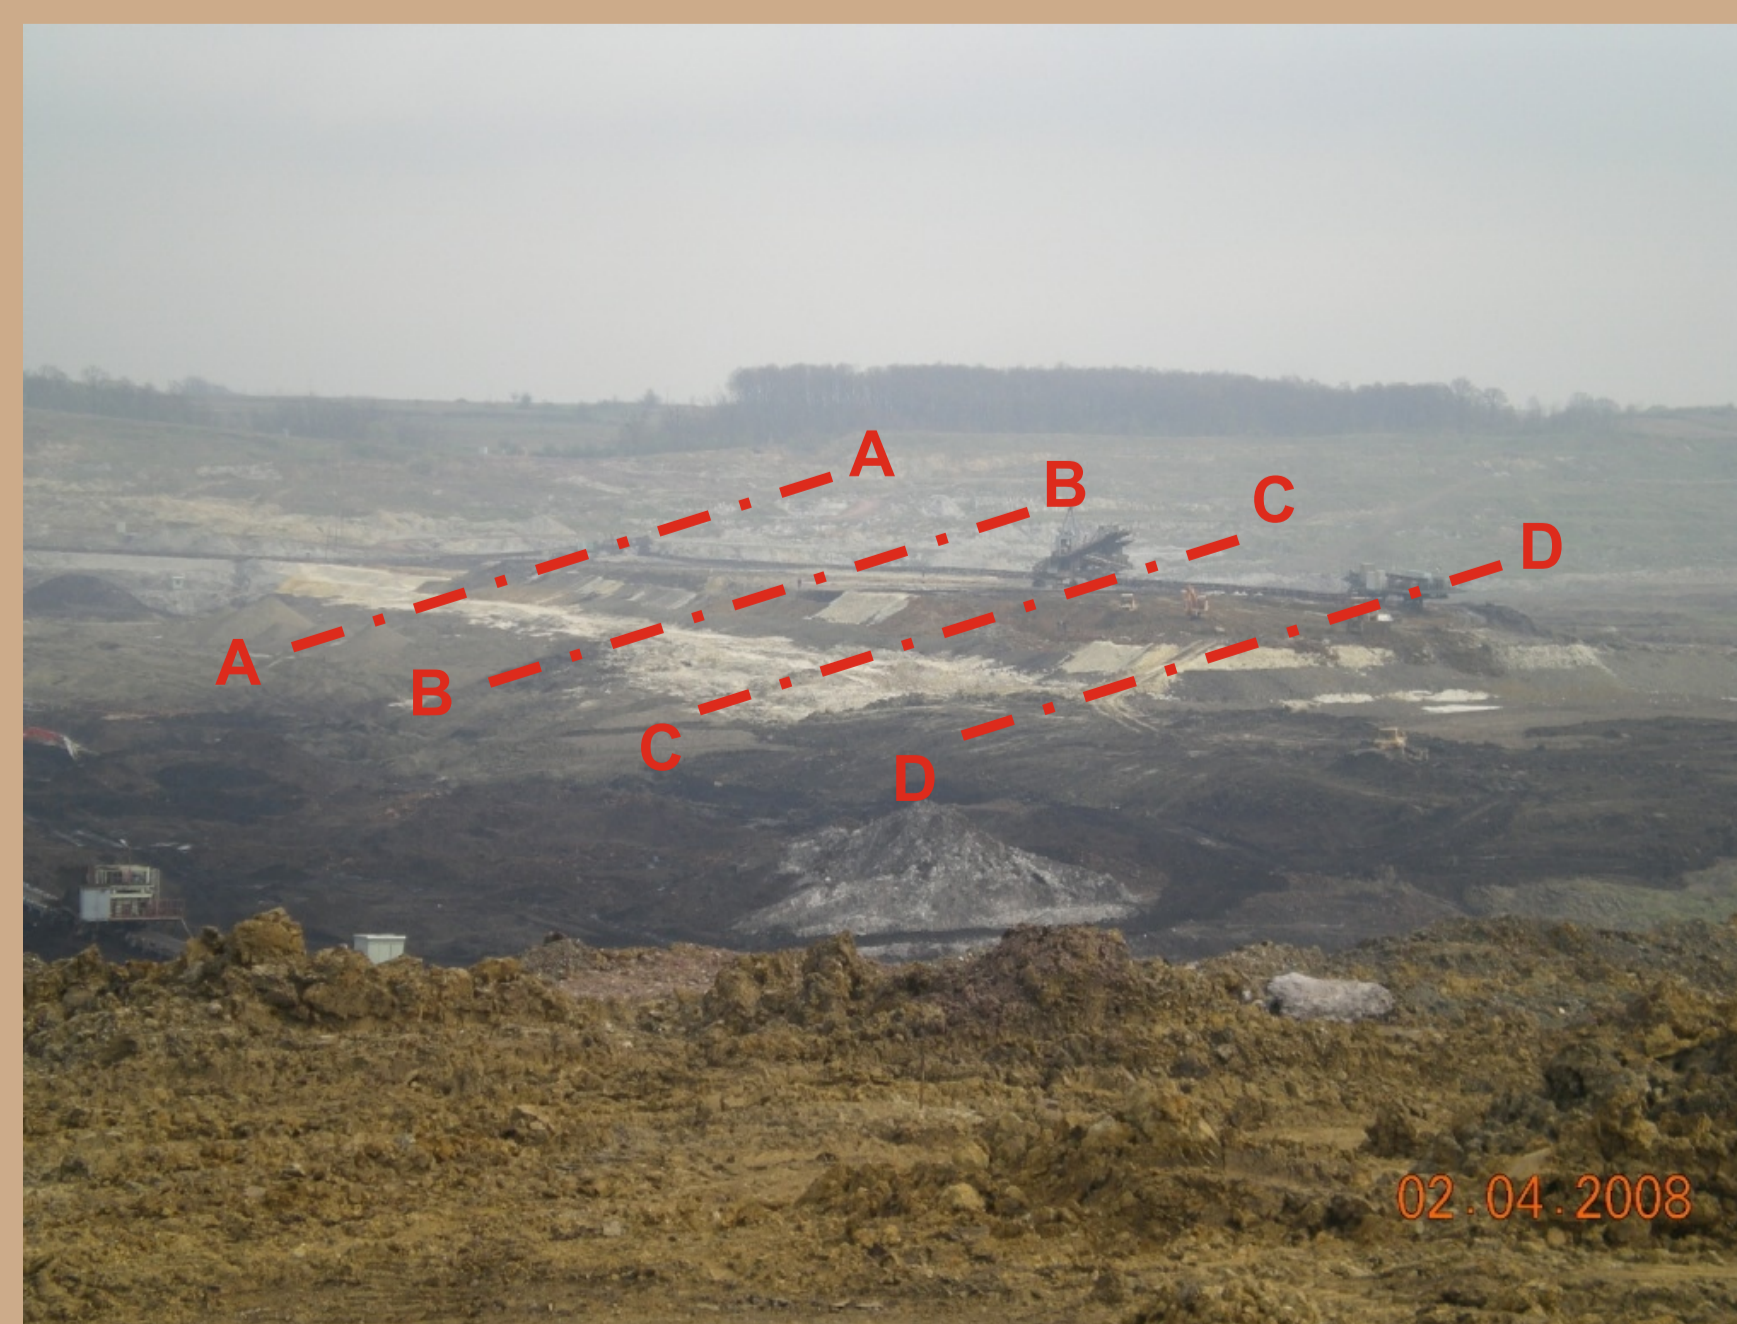
View on embankment during preloading

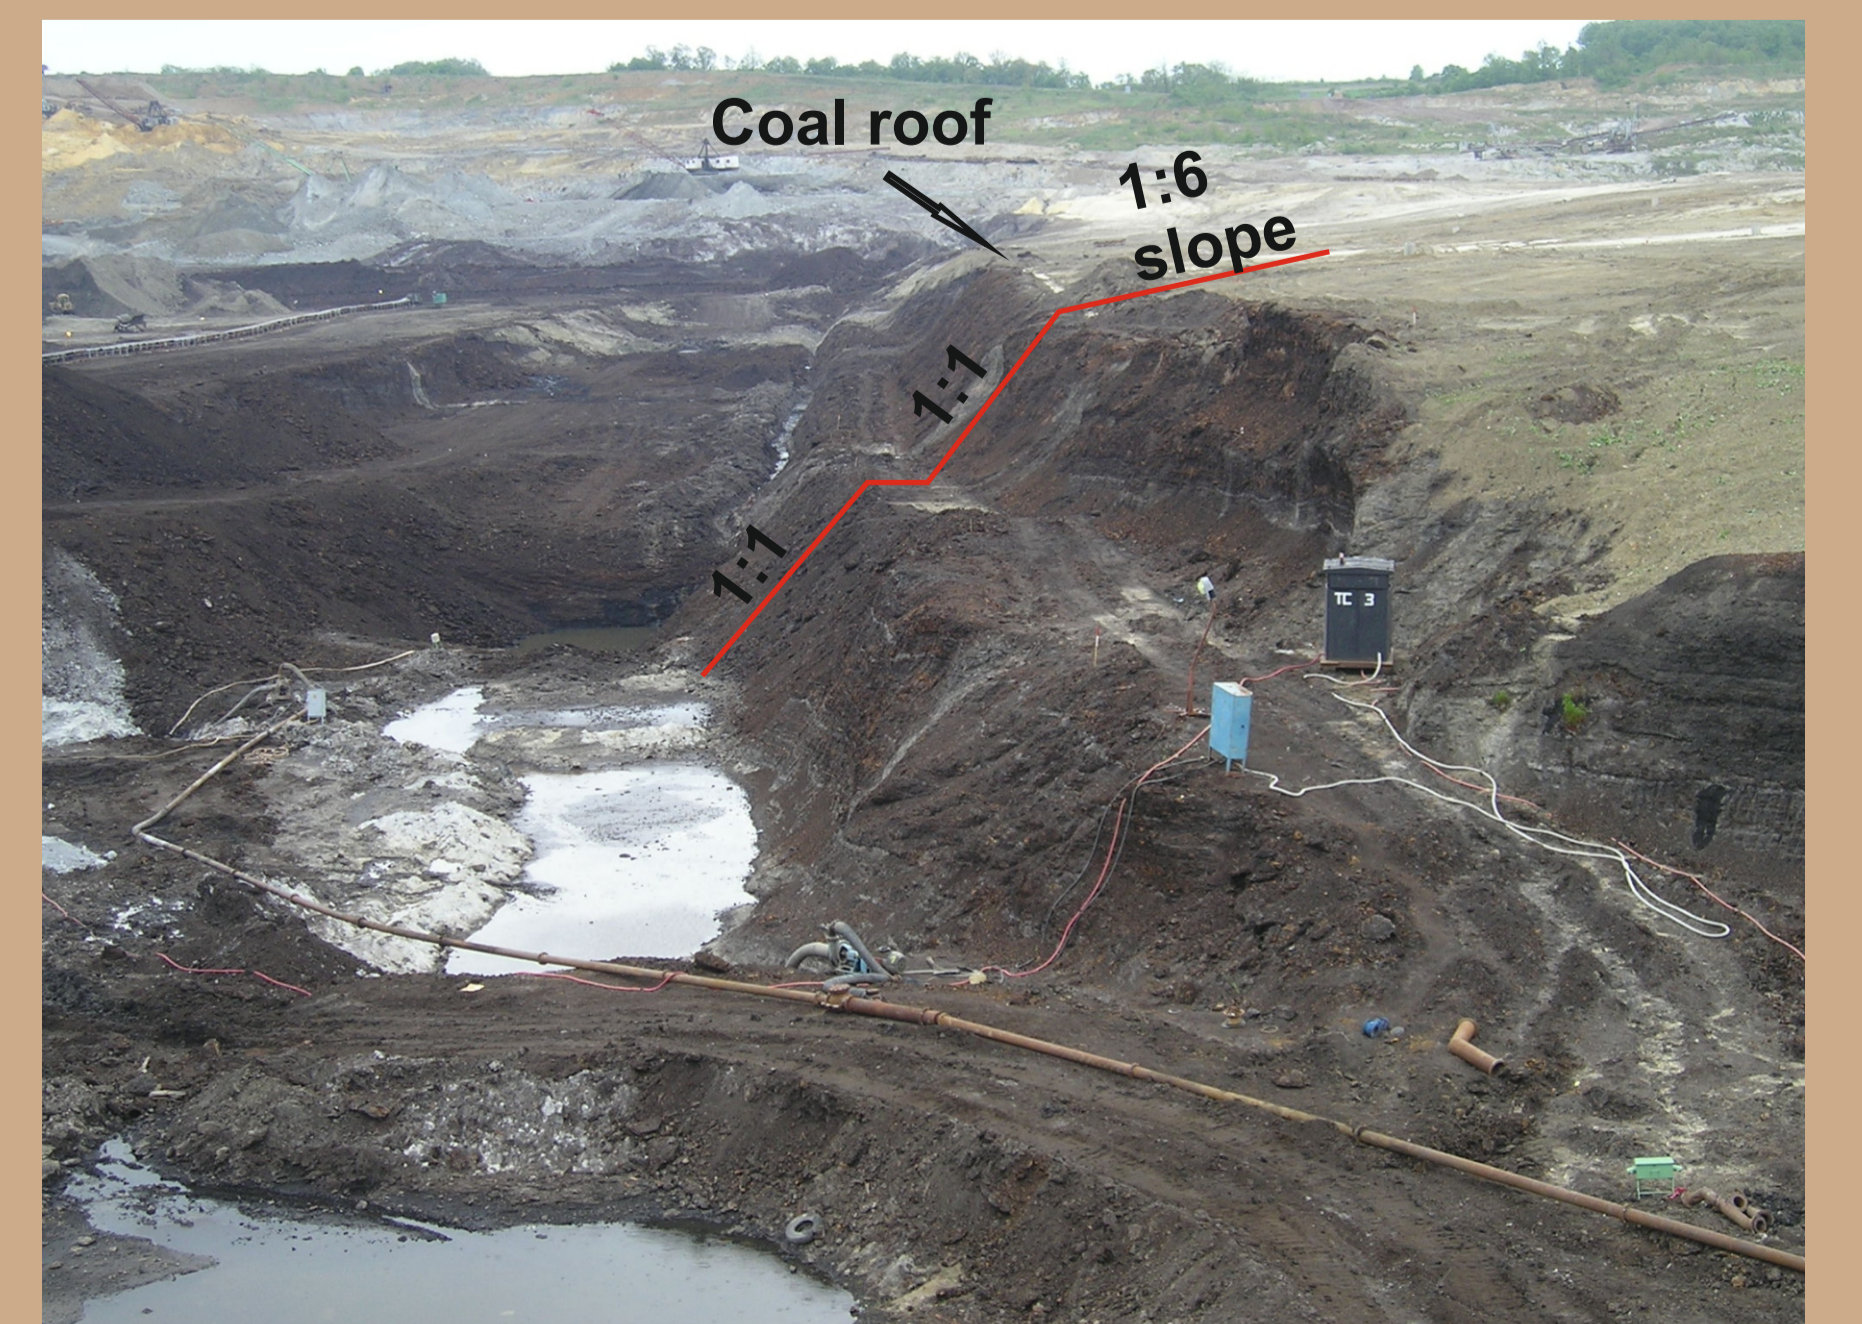
Coal excavation at the front after reopening of the coal mine in the field "B"
